DUNE REPLENISHMENT AND HABITAT RESTORATION PLAN

SUBJECT: Request for Authorization for an Annual Dune Replenishment Plan
55-271 & 55-273 Kamehameha Highway, Laie, Oahu, Hawaii
Tax Map Keys (1) 5-5-002:088 & (1) 5-5-002:019

Dune Replenishment and Habitat Restoration Plan

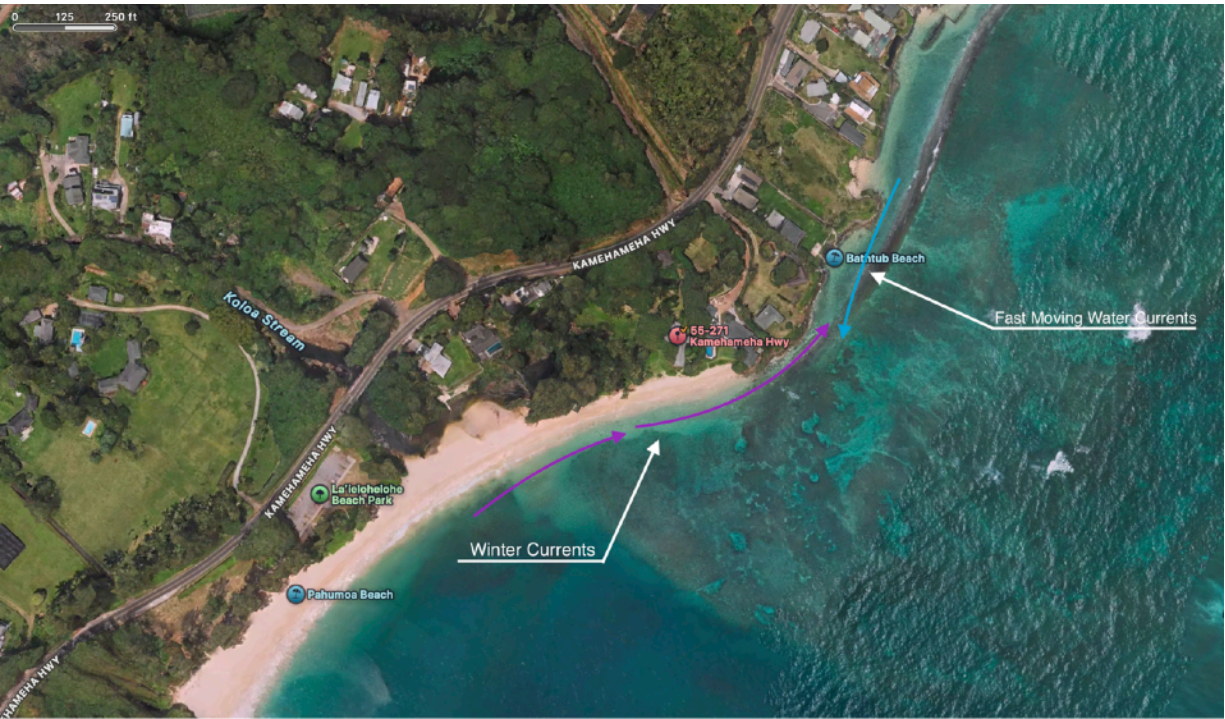
Figure 3-7: Currents Allowing Sand Accumulation at "Bathtub Beach"

our property. Only this specific set of conditions allows the sand to pass Kehuku'uana Point and form Bathtub Beach (Figure 3-7). Even when other ocean conditions are present (such as Northwestern swells in the winter, that cause the lateral near shore currents fronting our home to bring sand to our side of the beach) the sand can not pass Kehuku'uana Point due to the strong above mentioned currents. This creates a maximum width to the beach fronting our properties (Figure 3-8).

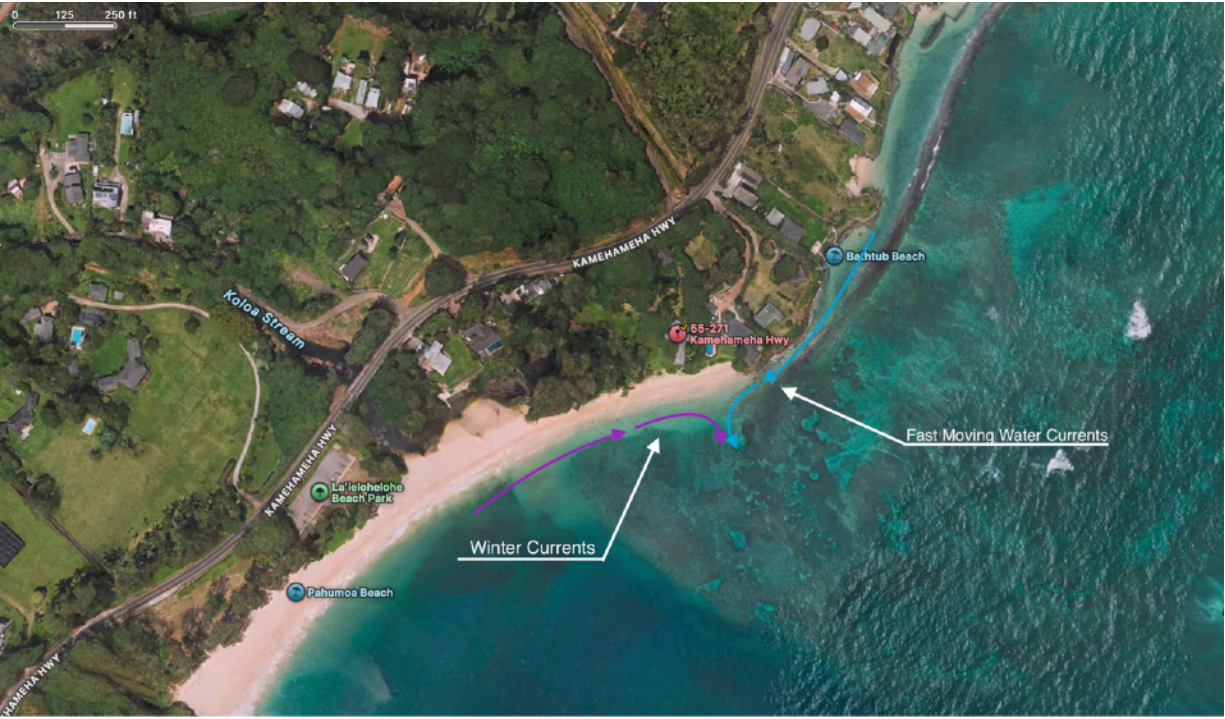
Figure 3-8: Competing Currents not Allow Sand Pass Point

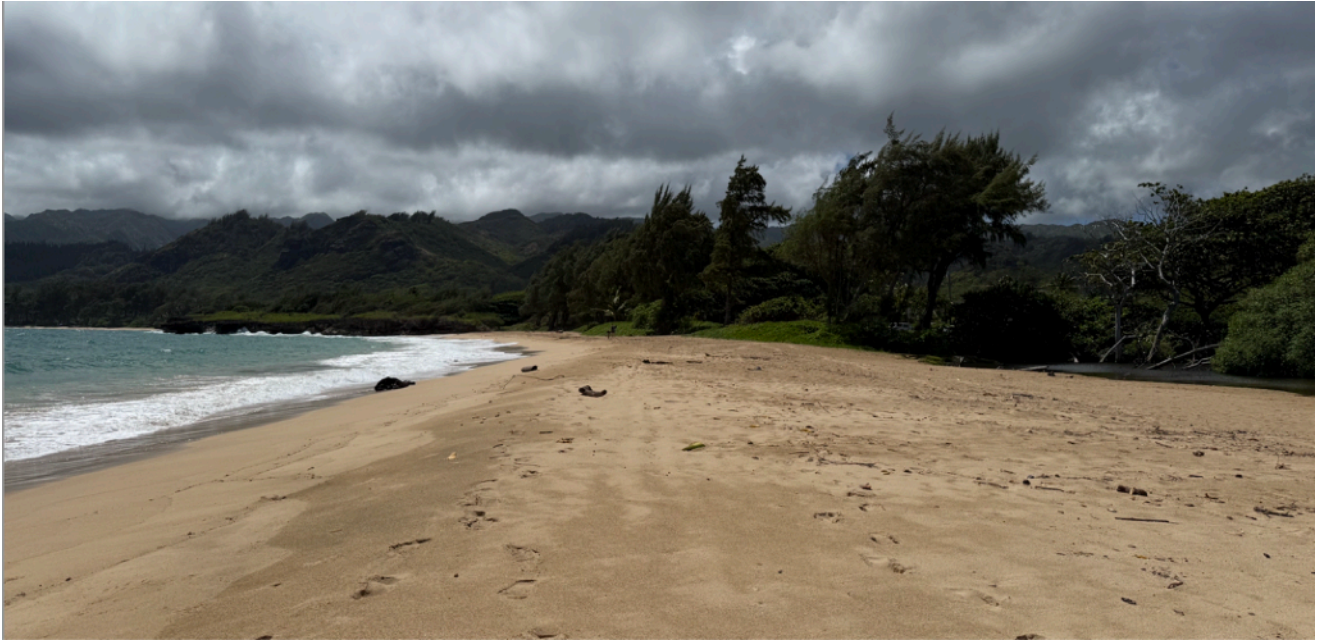
Figure 3-9A: Peak of Beach at Muliwai

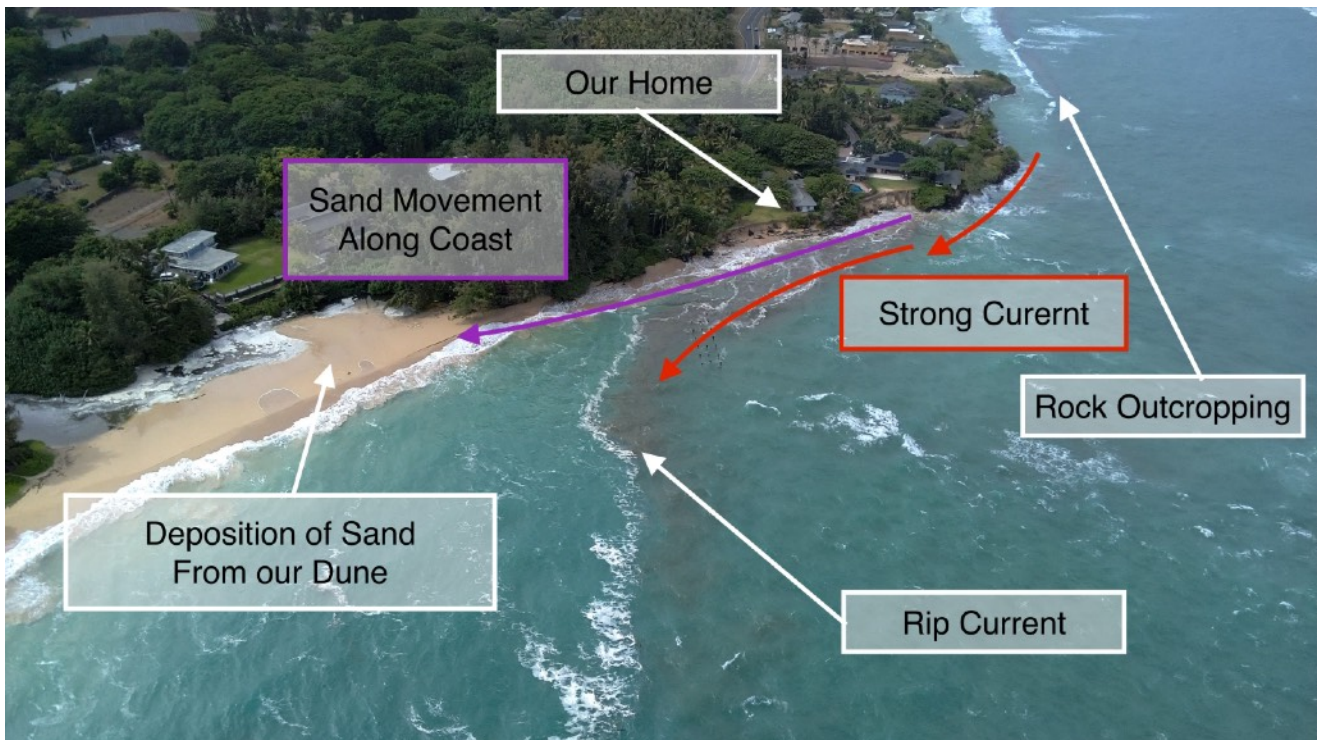
Figure 3-9B: Ocean Current and Transfer of Sand During Hurricane Kiko September 9, 2025

During Hurricane Kiko's passing of Oahu on September 9, 2025 we experienced an erosion event (Figure 3-9B). This storm's effects perfectly demonstrates what has been described above; Large ocean waves washed over the 1/3 mile long rock outcropping north of our property. The water existed at the only low point of the rock outcropping which directs the water out past our property and creates a strong current Labeled "Rip Current" in Figure 3-9B that quickly washed away the beach (approximately 50 feet wide) and a portion of our dune (approximately 5 feet wide). Figure 3-9C shows the beach from our most recent picture before the storm and how wide the beach was. The current carried that sand down the beach and because of the large swell the ocean pushed the eroded sand over the crest of the beach and into the Muliwai's sand reserve, labeled as "Deposition of Sand From our Dune" in Figure 3-9B where it will stay possibly for months, if not years. The only natural condition that allows for the sand to reenter the littoral beach system again is a heavy flow of stream water from Waialele and Koloa Streams that drain into the ocean through the muliwai.

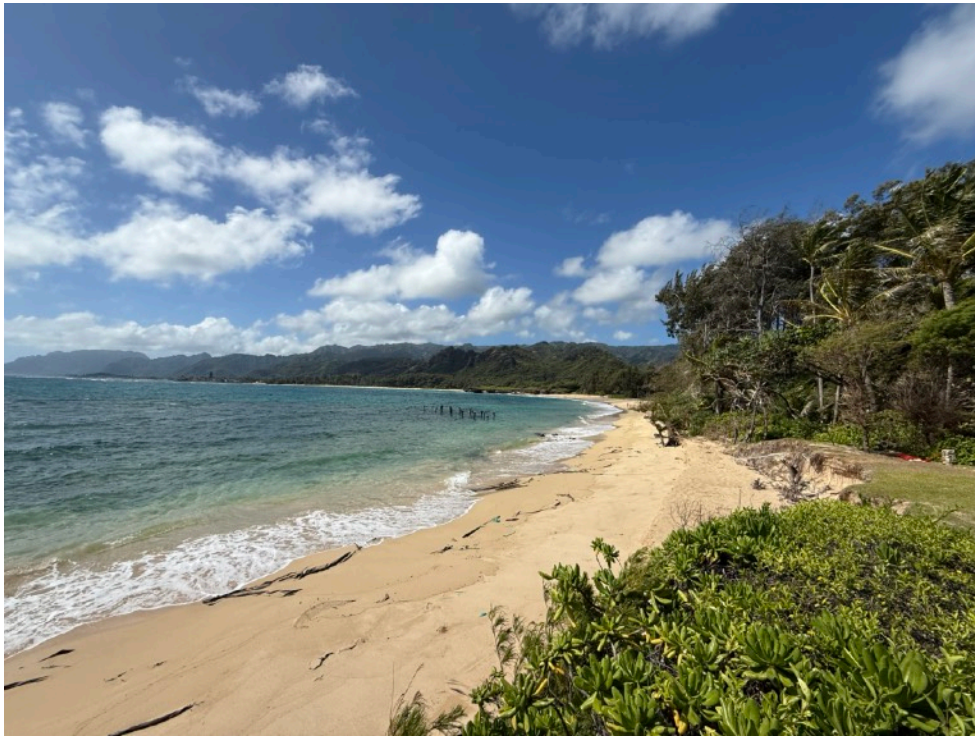
Figure 3-9C: Beach as of August 23, 2025 before storm

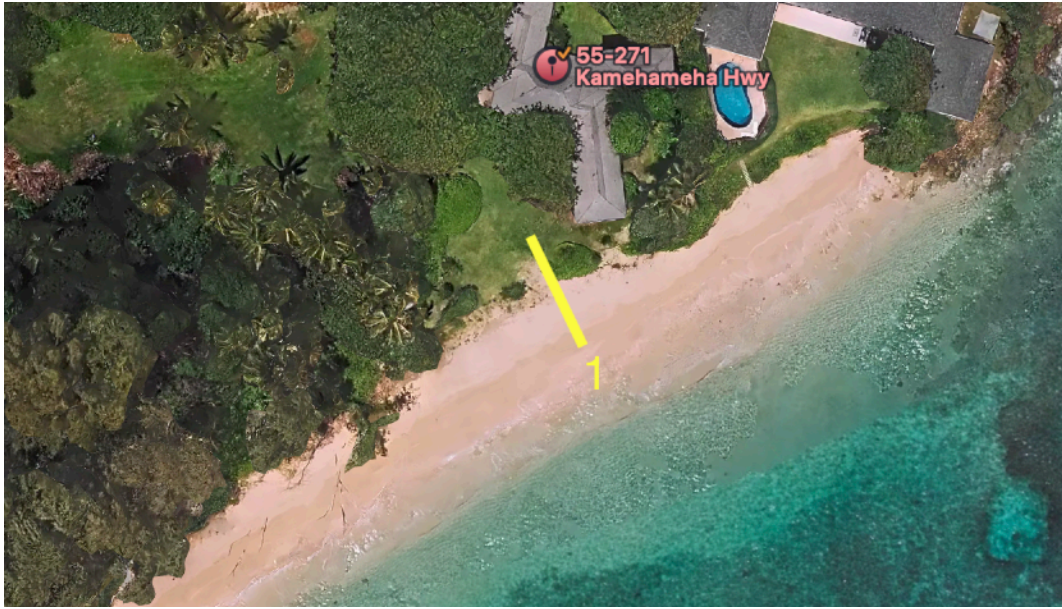
Figure 3-11: Cross Sectional Drawing of Beach, Dune, and Restoration

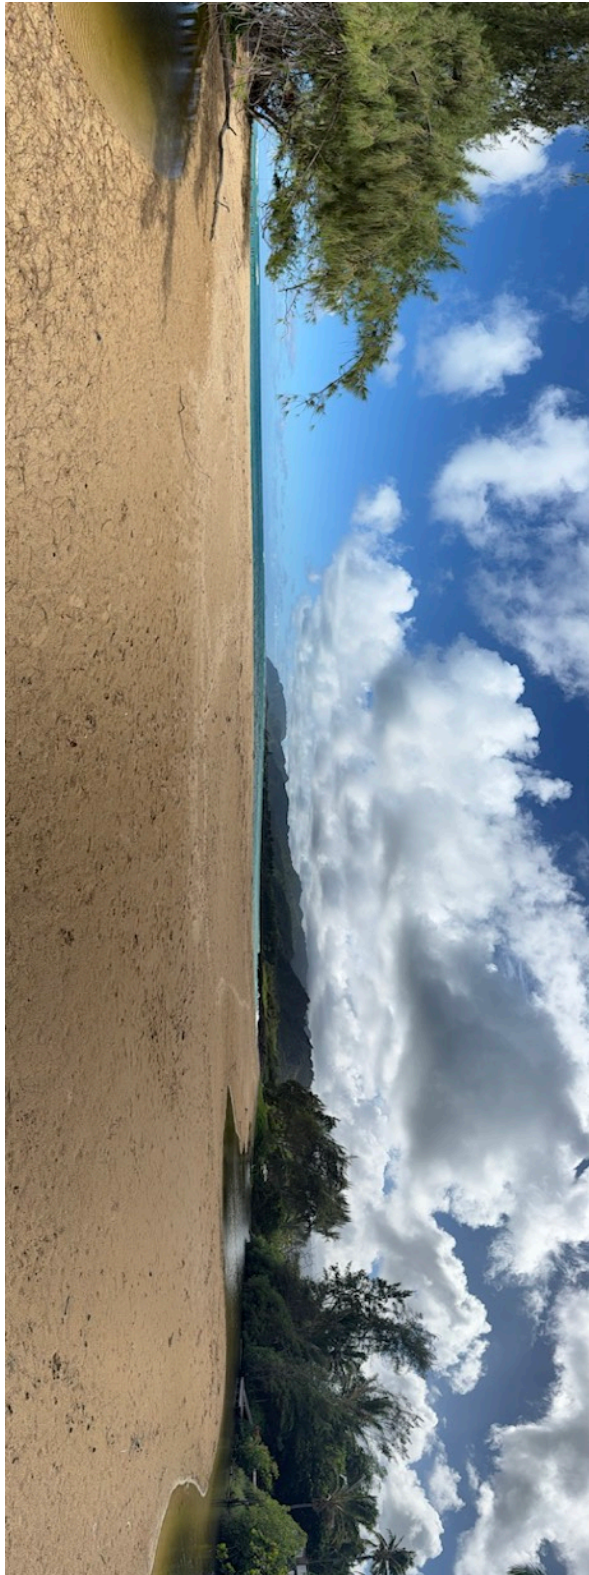
Figure 3-12: Muliwai's sand reserve as of September 22, 2025

The goal of this project is to create a sufficient dune barrier to allow for natural annual beach erosion without further mauka erosion of our property and loss of the beach. Much of the sand that erodes, both from the beach and our dune becomes sequestered in the muliwai (Figure 3-12). Once it washes into the basin, past the peak of the beach (Figure 3-9A) it effectively is lost to the beach system and ocean currents. Most of our severe erosion events occur during storms, high tides, and large swells; this is also when the ocean waves are able to push over the peak of the beach and into the muliwai's basin washing sand that was fronting our home into the muliwai and sequestering the sand for years at a time.
